Infrared Thermography & Acoustical Inspection Report

Infrared Thermography Services

Report Review and Summary

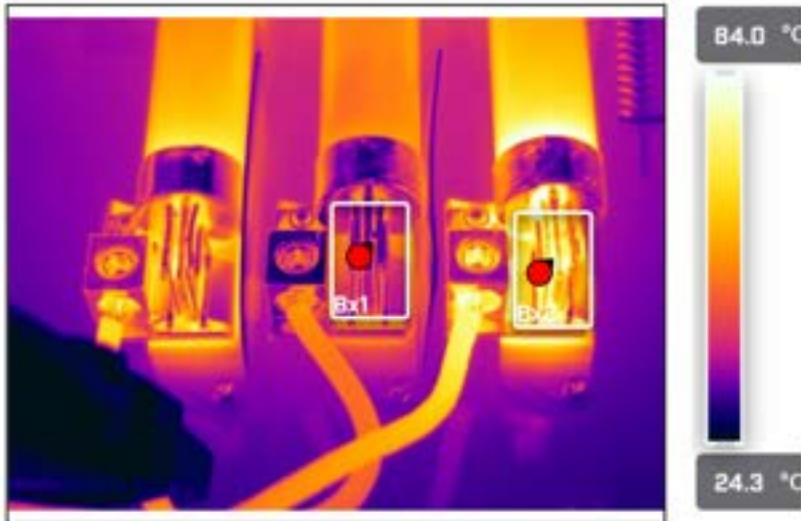
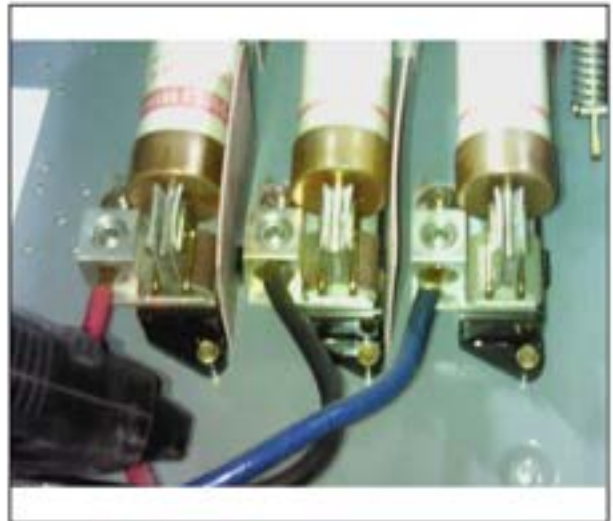
File Name: FLIR2183.jpg

Bx1	
Max	61.4 °C
Avg	44.1 °C
Bx2	
Max	93.2 °C
Avg	64.5 °C
Dt1	
Bx2.Max-Bx1.Max	31.7 °C

Temp. Difference(Dt1): 32 A - Major discrepancy, repair immediately

NOTE: Load side of 200A switch. Investigate, repair and re-scan.

Text annotations	
Location	Mech mezzanine
Floor / level	Second floor
Equipment	Switch fusible
Equipment ID	Compressor no.2
Circuit #	200amp sw
Ampacity	View recorded value noted as AC
Fault	Overheating at fuse clips
Recommendation	Clean, check and re-tighten.

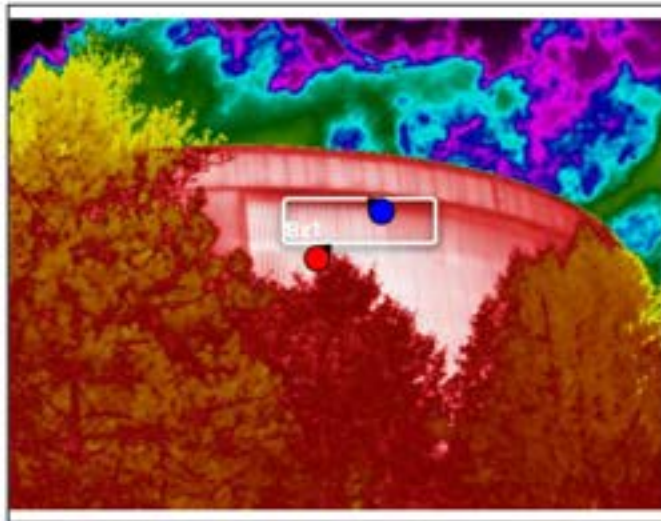
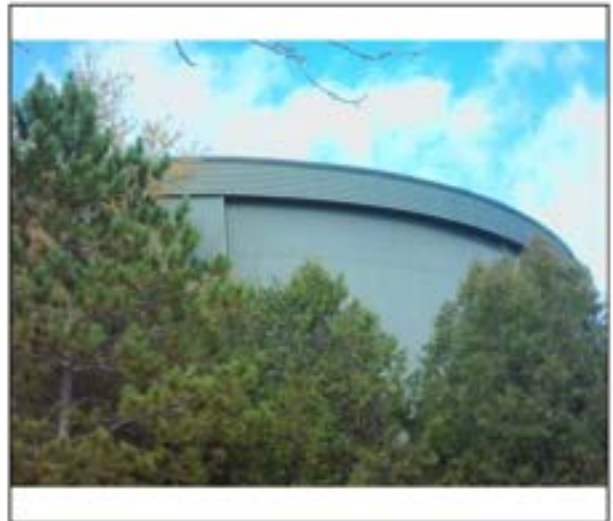
File Name: FLIR0692.jpg

Bx1	
Max	28.5 °C
Avg	25.7 °C
Min	21.8 °C

NOTE: Water tower structure. Client requested to see if thermal imaging could pick up water exfiltrating from the structural walls.

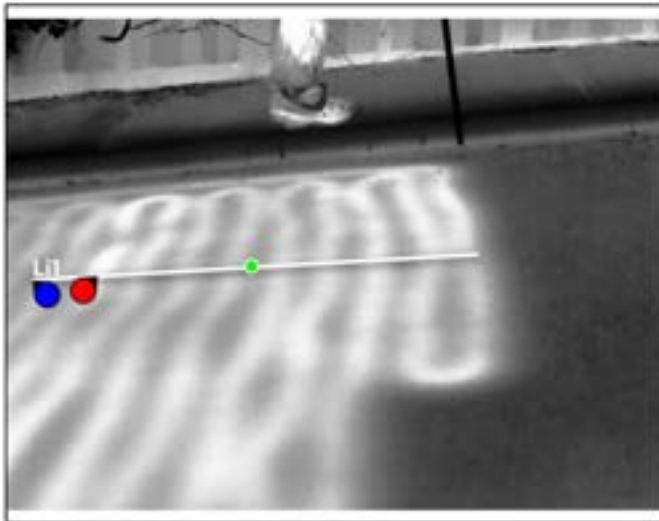
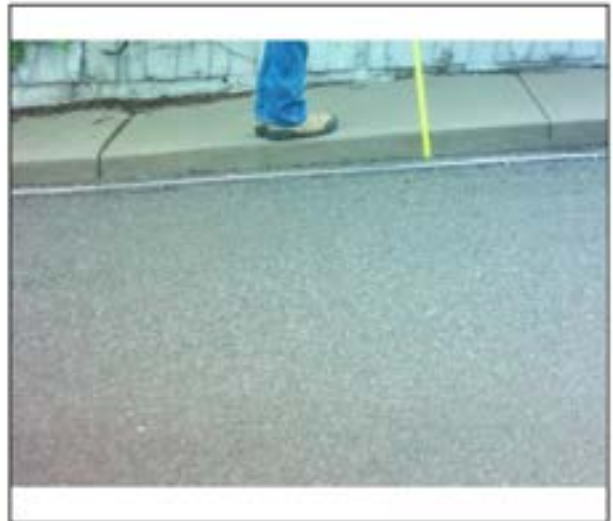
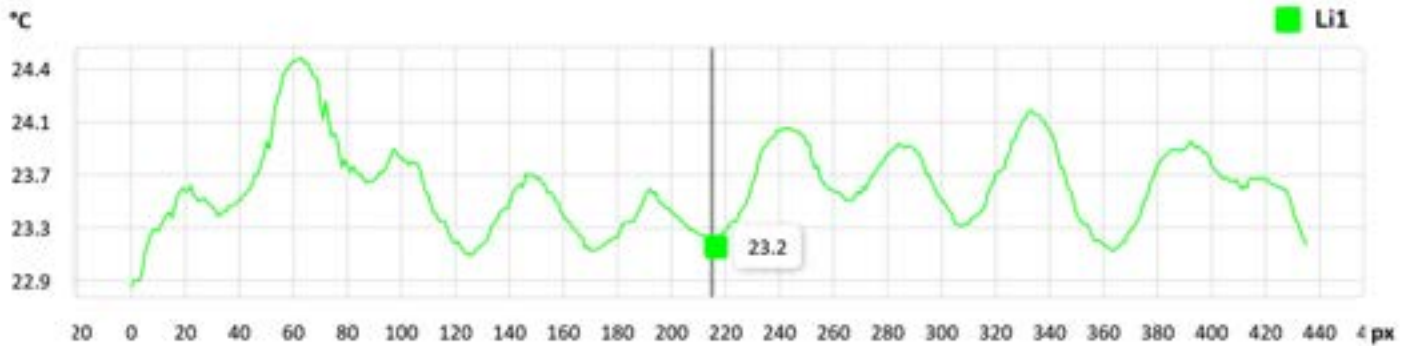
File Name: FLIR3079.jpg

Li1	
Max	24.5 °C
Avg	23.6 °C
Min	22.8 °C

NOTE: Radiant ramp heating for an underground parking garage. Local university, client needed to confirm location of cables that were and are not functioning for repairs. Plot is the measurement line Li1 profile.

Note: End at 83ft from garage door frame. Down ramp

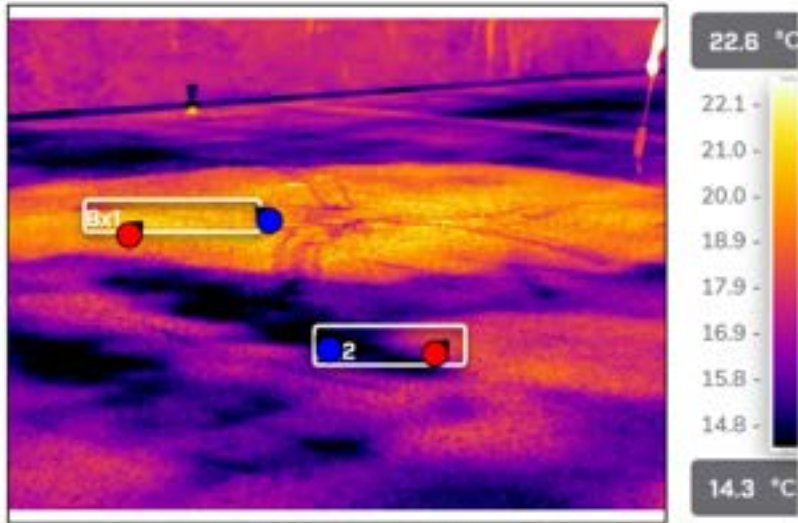
File Name: FLIR1527.jpg

Bx1	
Max	22.2 °C
Avg	20.0 °C
Min	17.3 °C
Bx2	
Max	18.8 °C
Avg	15.8 °C
Min	13.1 °C

NOTE: Area between quadrant A & B . Again mix of dry and humid area. Humid area is around roof drain

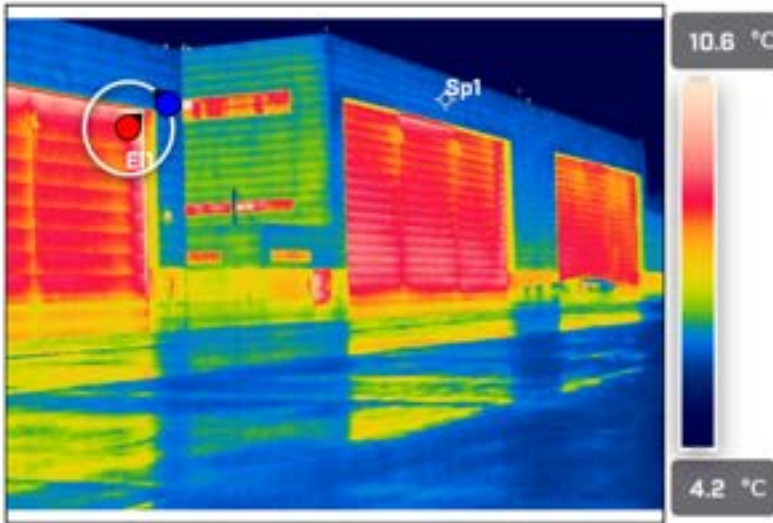
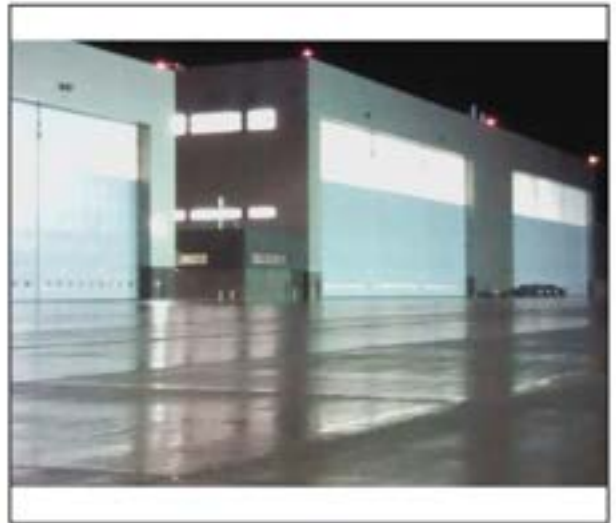
File Name: FLIR0771.jpg

E1	
Max	12.9 °C
Avg	7.9 °C
Min	5.8 °C
Sp1	6.0 °C

NOTE: Building no. 1, airport aircraft hanger for Global Master aircrafts. Building inspection conducted for air tightness

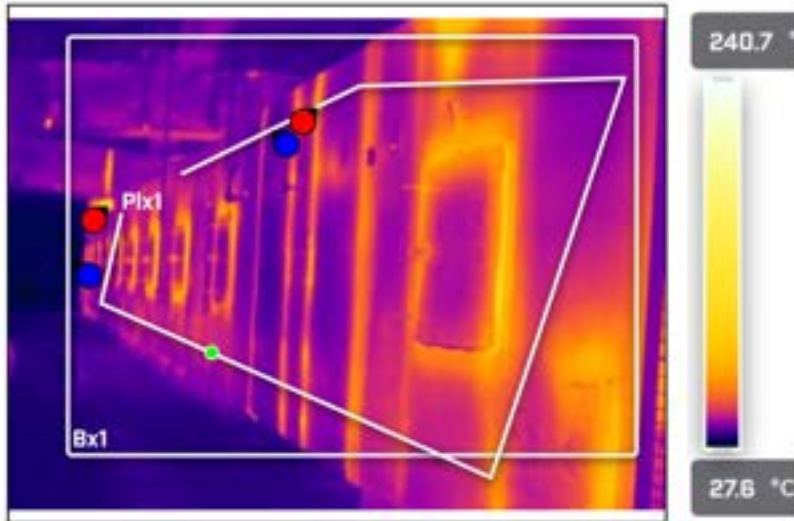
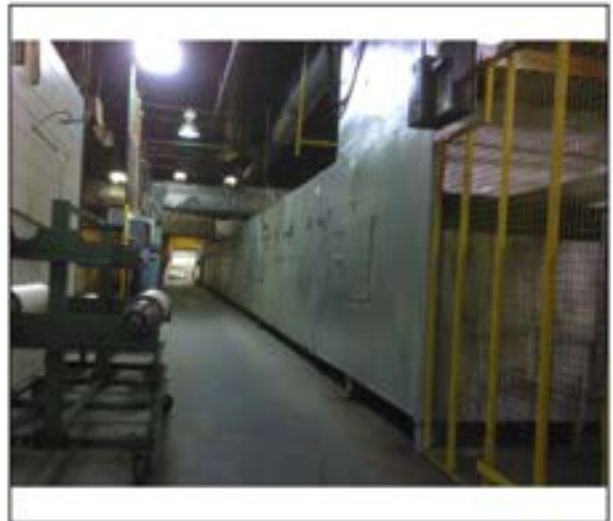
File Name: IR_0254.jpg

Bx1	
Max	170.5 °C
Avg	58.9 °C
Min	27.5 °C
Plx1	
Max	96.1 °C
Avg	58.4 °C
Min	44.8 °C

NOTE: Line furnace ovens for paint drying of rolling sheet metal. IR enables to view efficiency of furnace walls.

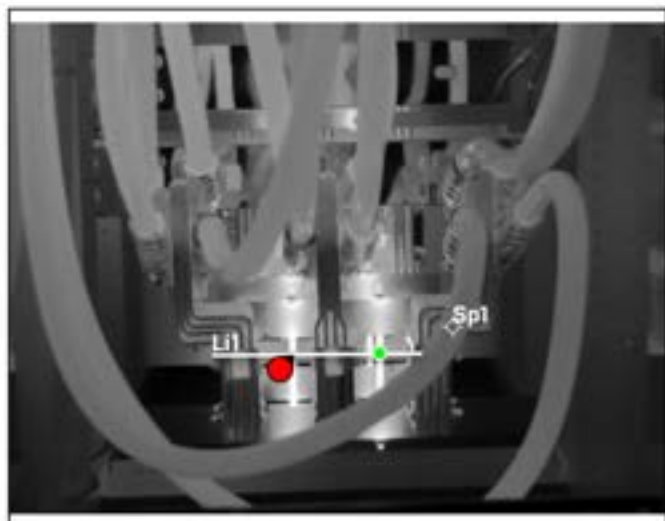
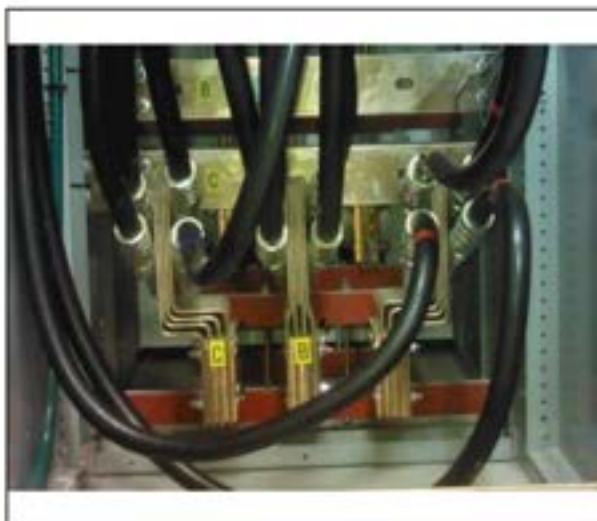
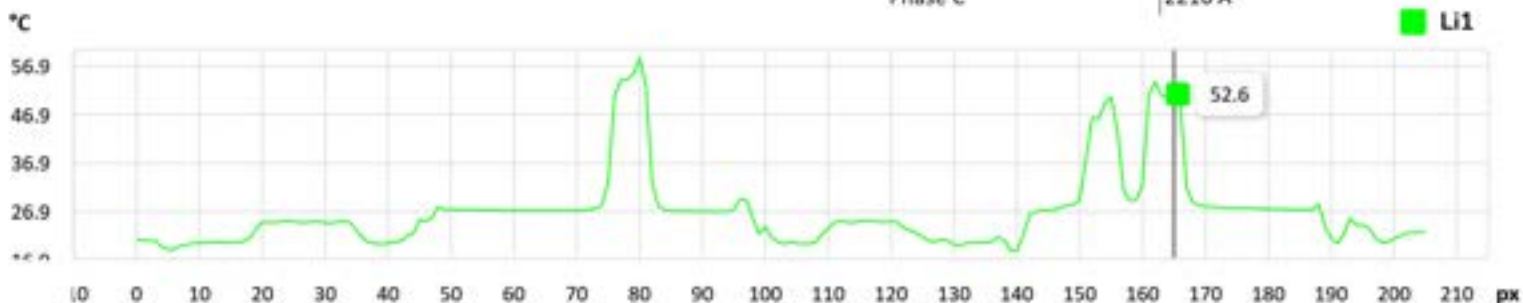
File Name: FLIR1459.jpg

Lj1	
Max	58.5 °C Line measurement plot shown.
Avg	26.8 °C
Sp1	22.1 °C

Phase A	2150 A
Phase B	2219 A
Phase C	2216 A

Location	Main elect rm
Generator component	Cell 2 gen 2 breaker
CMMS	10-125-0006
Generator's electrical distribution	Feed to Emerg. panel. 3200 Amp breaker
Information	1hr into load bank test
Fault	no fault
Recommendation	for trending purposes

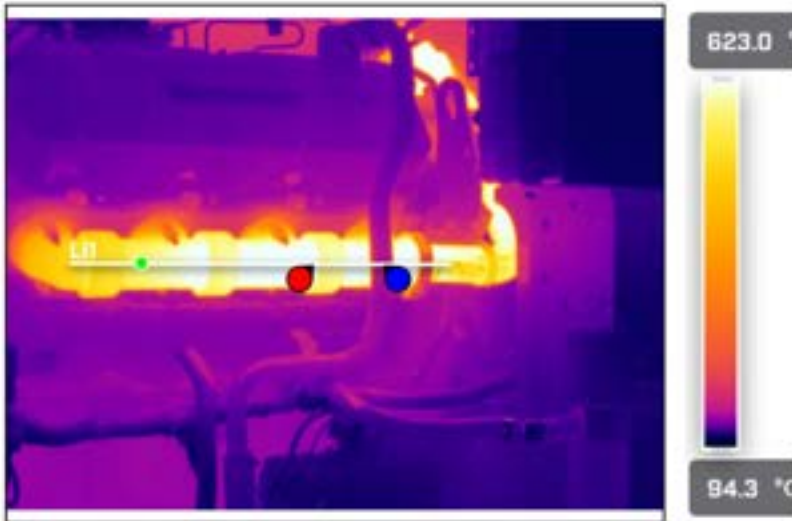
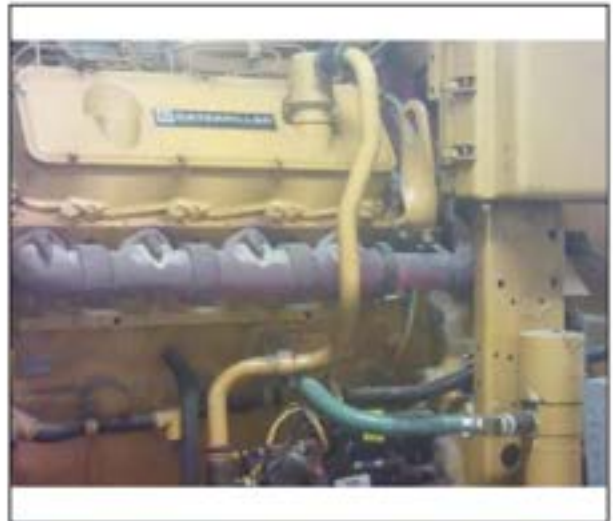
File Name: FLIR1472.jpg

LI1	
Max	644.8 °C
Avg	*561.4 °C
Min	*164.9 °C

Phase A	370.4A
Phase B	365.4A
Phase C	352.8A

NOTE: Generator load testing per CSA 282. Images are collected and compared from other yearly inspections for changes in equipment condition.

Location	Generator room
Generator component	engine exhaust
CMMS	n/a
Generator control panel	n/a
Information	90 minutes into generator load test
Fault	no fault
Recommendation	for trending purposes

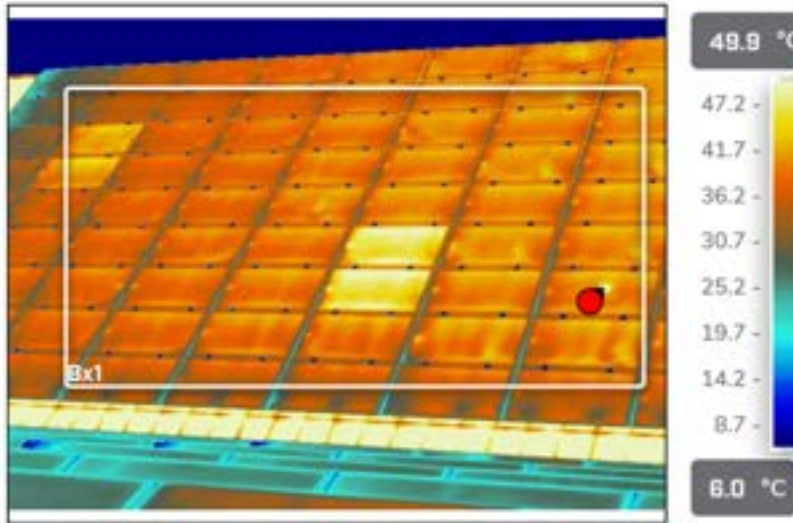
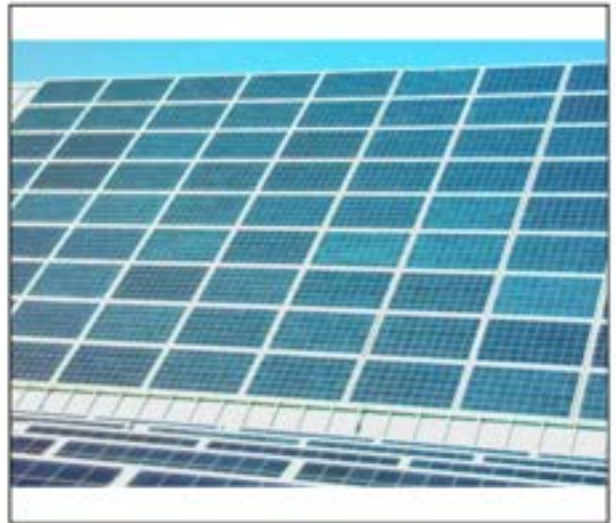
File Name: FLIRD414 - Copy.jpg

Bx1	
Max	59.8 °C
Avg	39.4 °C

NOTE: Local High School, large array

IR cameras can easily detect hot spots, defective or off line solar panels in an installed array.
 Large sections of photo-voltaic cells can be scanned in a single sweep.

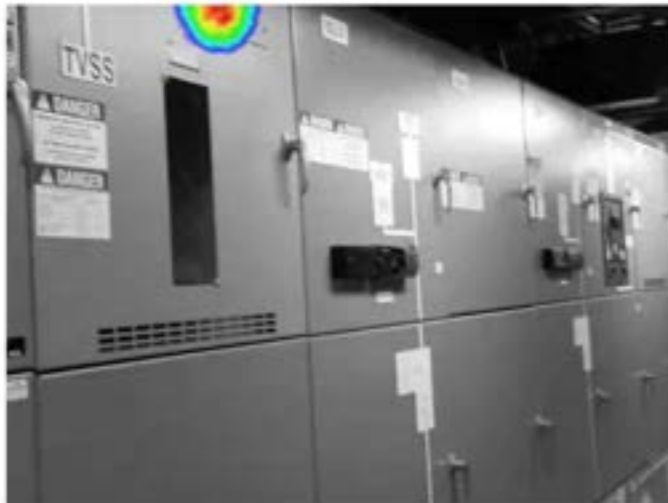
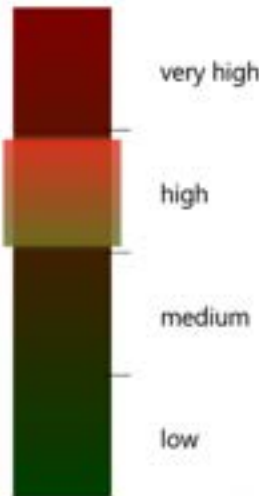
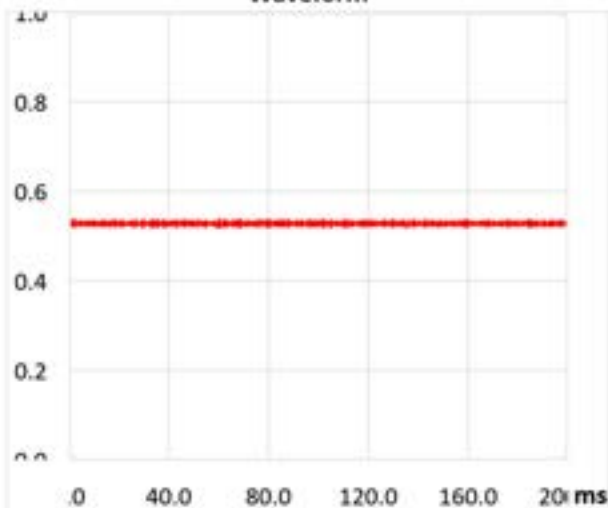
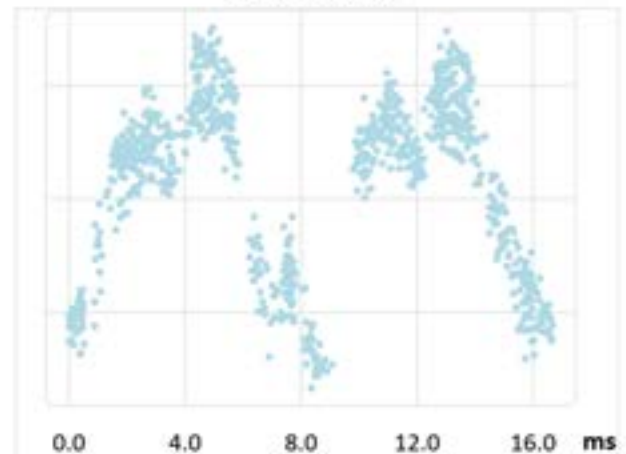
File name	AC13T810_00018_240302_1157_0018
Created	2024-03-02 11:58:07 AM
Camera serial	AC13T810
Measured dB	22.5 dB
Voltage	0.6 kV
Distance	2.00 m
Location	switchgear

This is classified as a surface or internal discharge. The discharge appears to be strong and might rapidly escalate to complete insulation breakdown.

Immediate action. Visual inspection. Cleaning of polluted surfaces. Repair or replacement of the components.

Electrical room main switchgear. Acoustic imager used to locate possible arcing within cabinet without opening covers and doors.

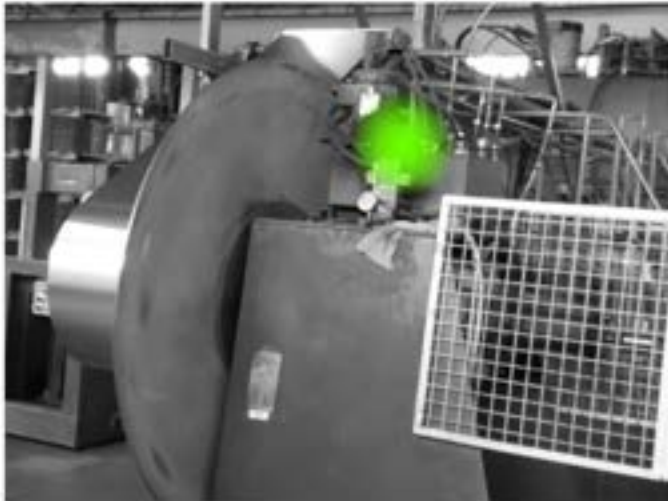
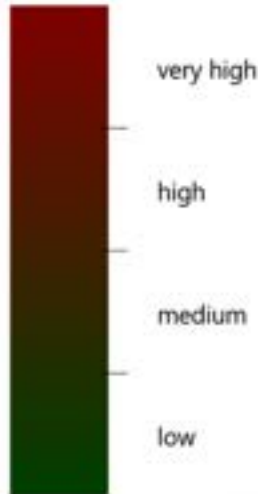
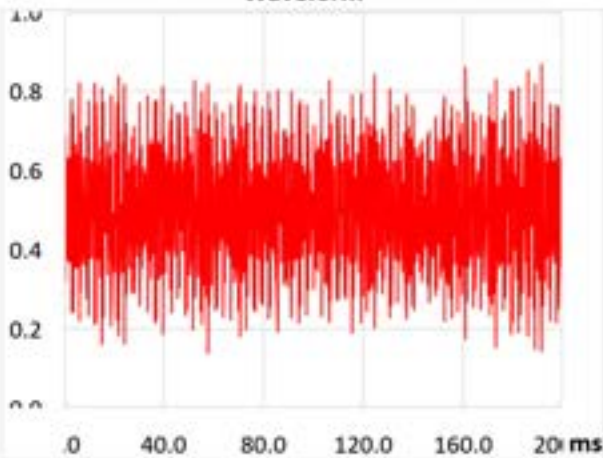
File name	AC13T810_00005_231102_1520_0005
Created	2023-11-02 3:20:53 PM
Camera serial	AC13T810
Measured dB	30.6 dB
Voltage	
Distance	10.00 m
Location	Roller run off, start of line.

Air solenoid valve purging. No issues here.

56.89 \$ based on energy cost
 13.47 L/min 30.6 dB
 Based on
 50 weeks per year
 6 days per week
 12hrs per day

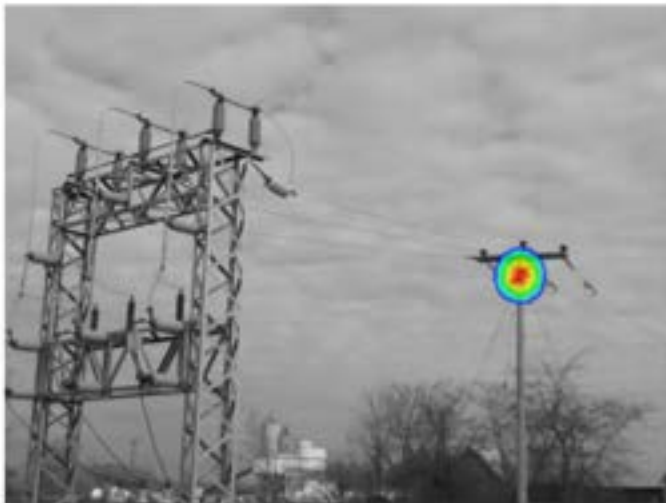
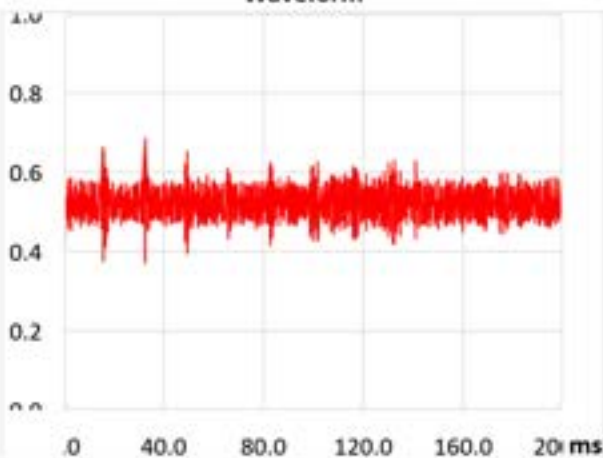
File name	AC13T810_00004_231102_1519_0004
Created	2023-11-02 3:19:22 PM
Camera serial	AC13T810
Measured dB	-3.3 dB
Voltage	13.5 kV
Distance	50.00 m
Location	support insulator

The detected sound source does not resemble a partial discharge. It might be another type of sound source or a reflection from another type of sound source. If you are unsure, take more snapshots of the location from different angles and at different times. Also ensure that the AC frequency is correct. The partial discharge analysis will fail if the AC frequency is incorrect.

Typically no action required.

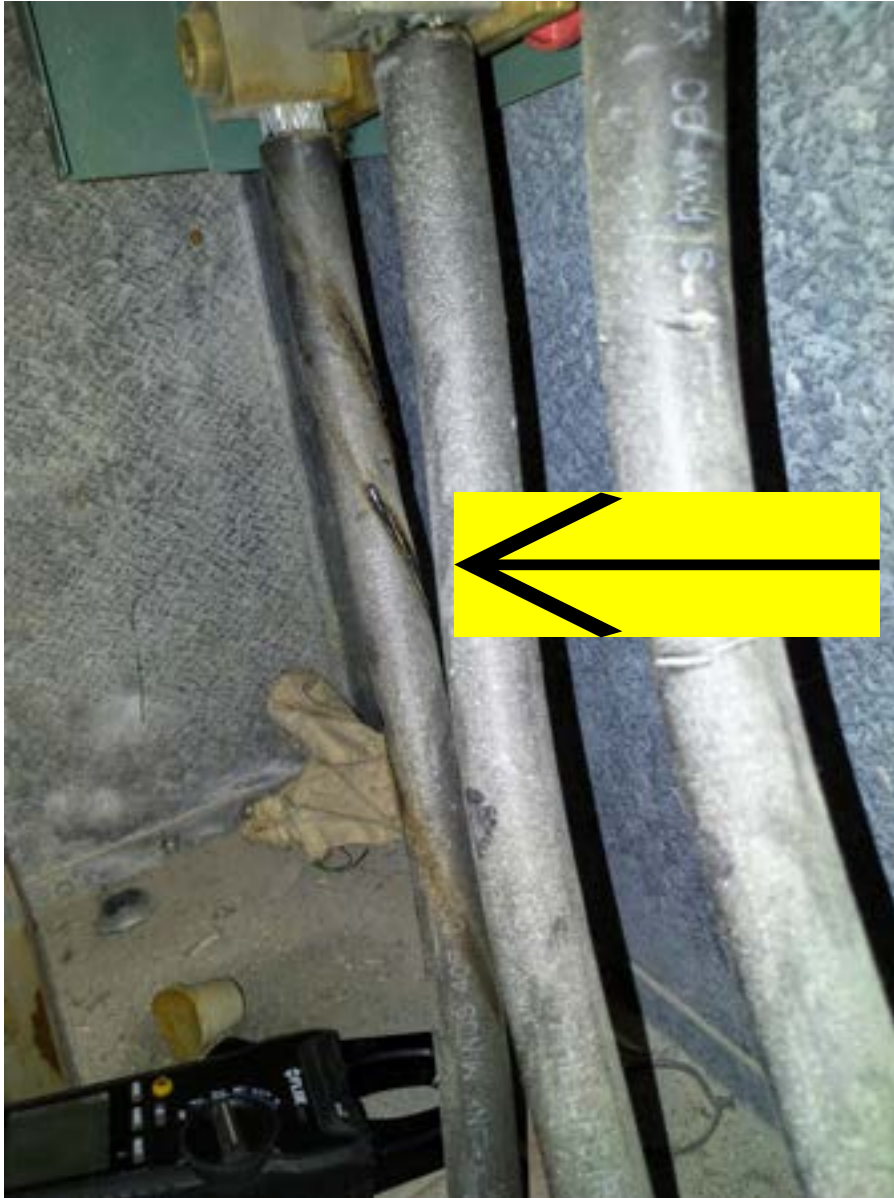
Our IR inspections are complimentary to visual inspections which allows us to view anomalies that would have gone undetected if electrical equipment would not be opened for proper viewing. Here, a slit was noticed in many of the feeder cables. The slit went all the way to the aluminum conductor. This was brought up to the client which was able to remedy the issues.

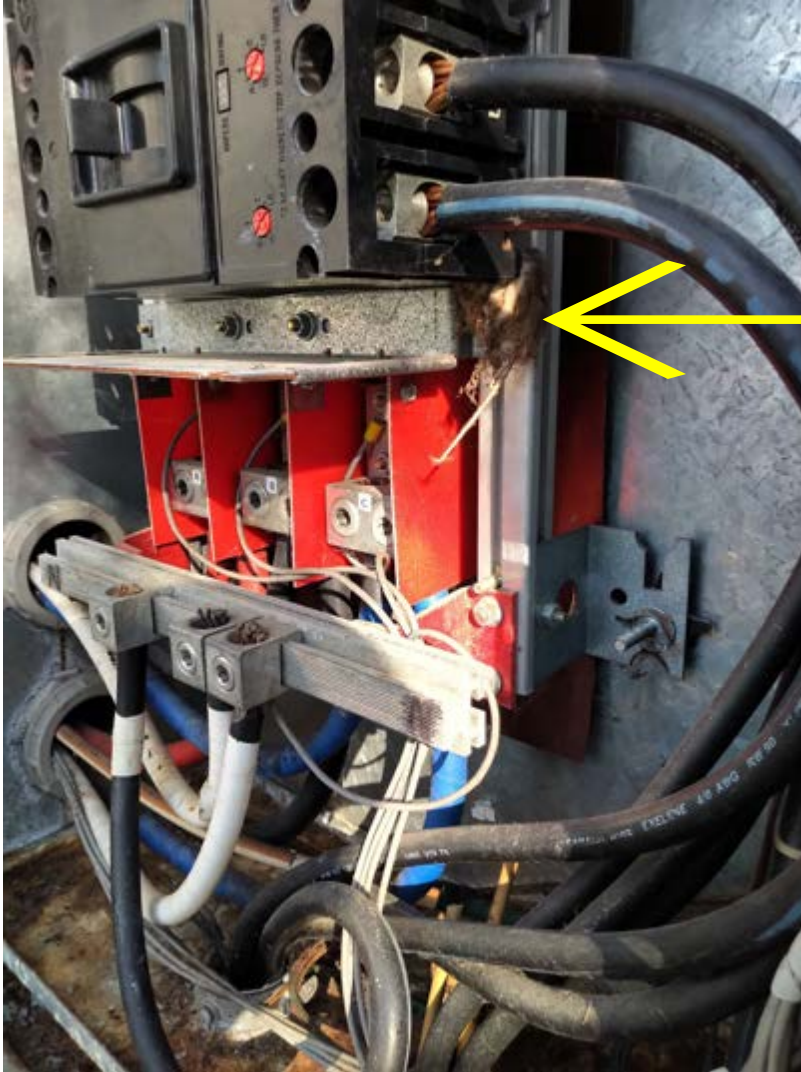
Small rodents are also found inside cabinets that have open holes which have not been sealed.
